National Dam Inspection Program.  
Lackawanna Dam (NDS-ID-PA-00913, DER-ID-35-139), Susquehanna River Basin, South Branch Tunkhannock Creek, Lackawanna County, Pennsylvania. Phase I Inspection Report.

LACKAWANNA DAM

PHASE I INSPECTION REPORT

NATIONAL DAM INSPECTION PROGRAM

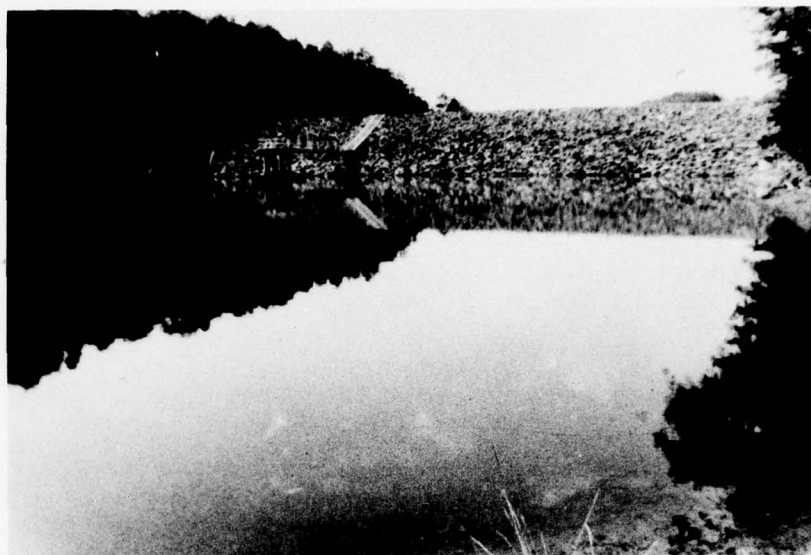
(2) The rockfill on the upstream slope of the embankment was in good condition except at the top of the dam adjacent to the spillway (Photographs A, B, and F), where vandals have thrown stones into the spillway chute. The rockfill on the upstream slope is sound, well-graded red and gray sandstone. It varies in size from 6 to 24 inches.

A. Embankment.  
View from Upstream.

(1) Replace riprap on upstream slope and restore embankment to design elevation.

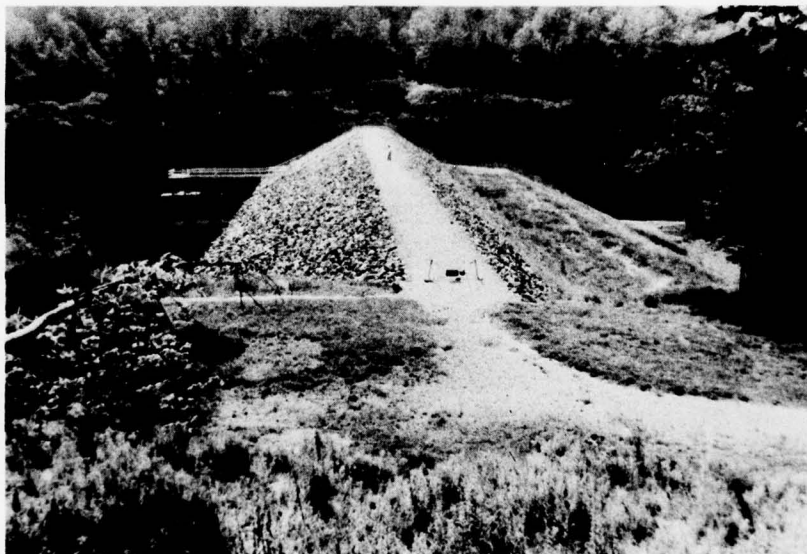
(2) The loss of stone on the upstream slope at the top of the embankment adjacent to the spillway has caused the aforementioned low area to develop. Unless the stone is replaced, the limits of the low area will probably become larger.

B. Embankment.  
View from Right Hillside.

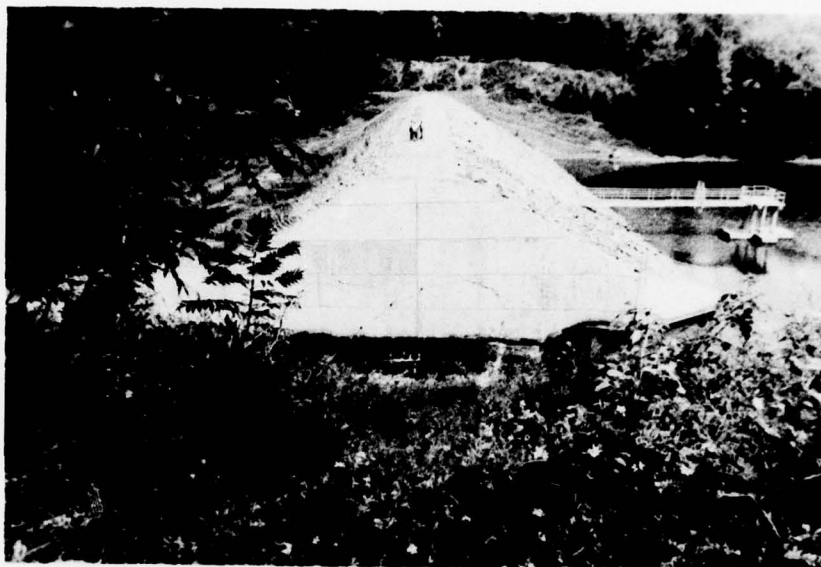
(1) Spillway. The spillway had no apparent deficiencies. All concrete structures were in good condition (Photographs C, G, and J). Backfill concrete that was placed by the Corps of Engineers to repair erosion damage that occurred during the June 1972 flood was also in good condition. The exposed rock surfaces in the chute section were irregular and some fractures were visible (Photograph H). It was noted that the combination of the location of the weir and the height of the spillway training wall will probably produce flow across the upstream slope of the embankment parallel to the axis of the dam at high pool levels (Photographs C and F).

C. Spillway and Embankment.  
View from Left Hillside.

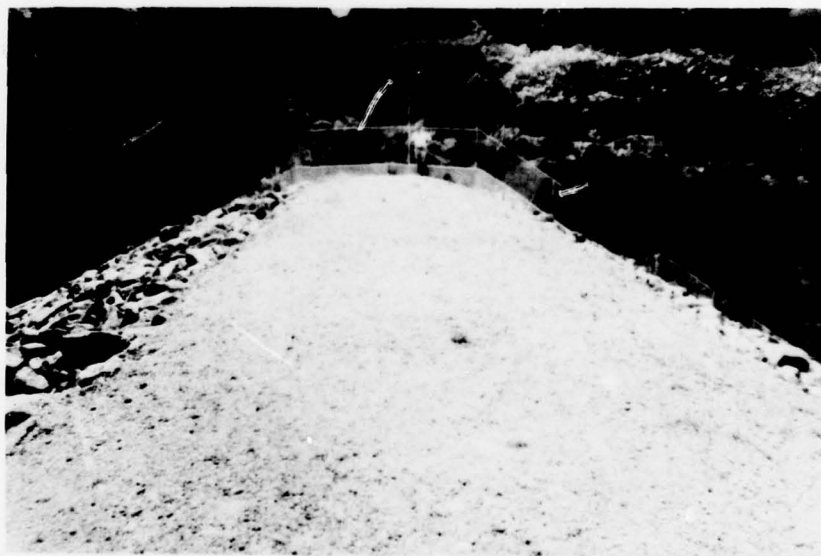
D. Low Area at Spillway Training Wall.

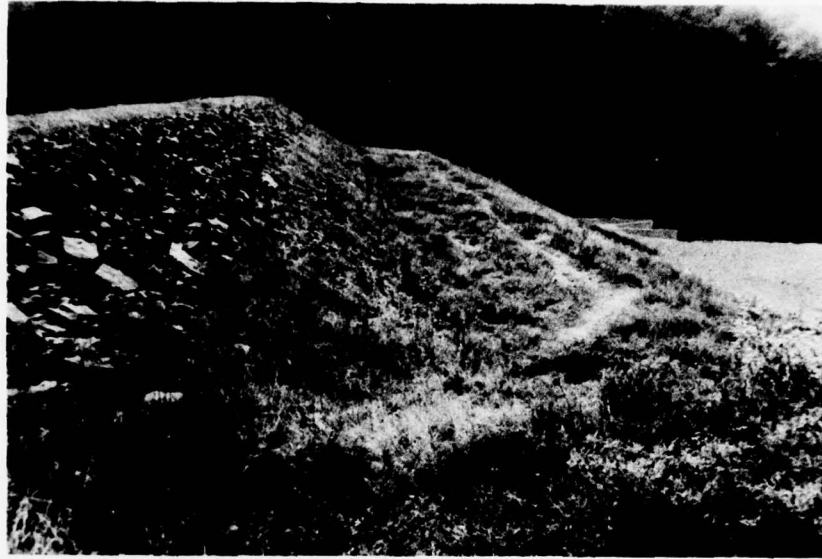
E. Downstream Slopes of Embankment.  
View from Right Abutment.

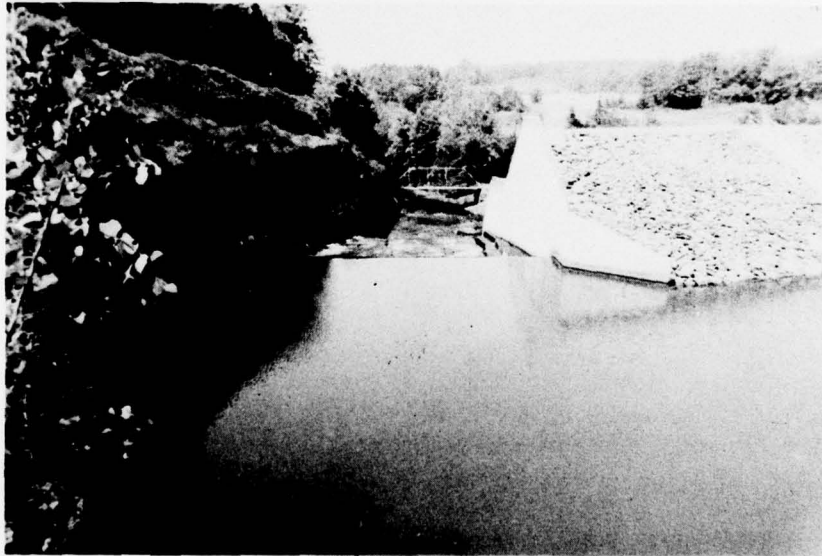
F. Spillway Approach Channel.

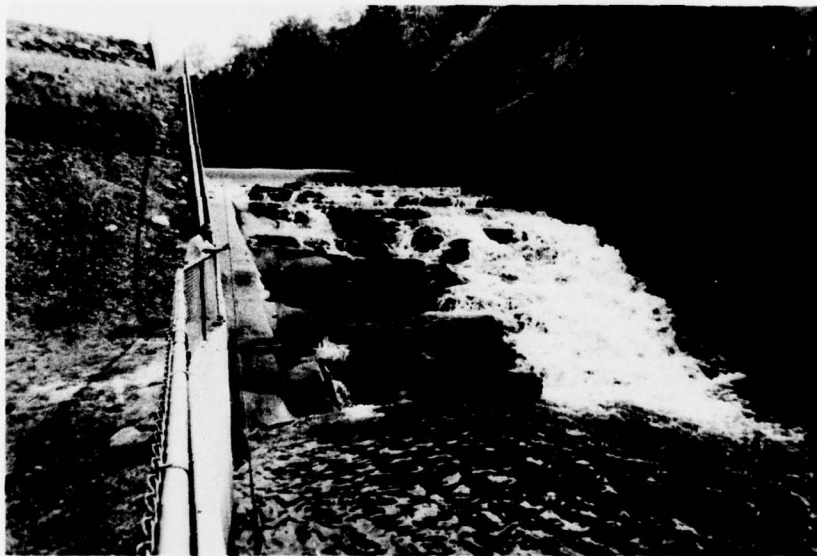
H. Spillway Outlet Channel and Stilling Basin.

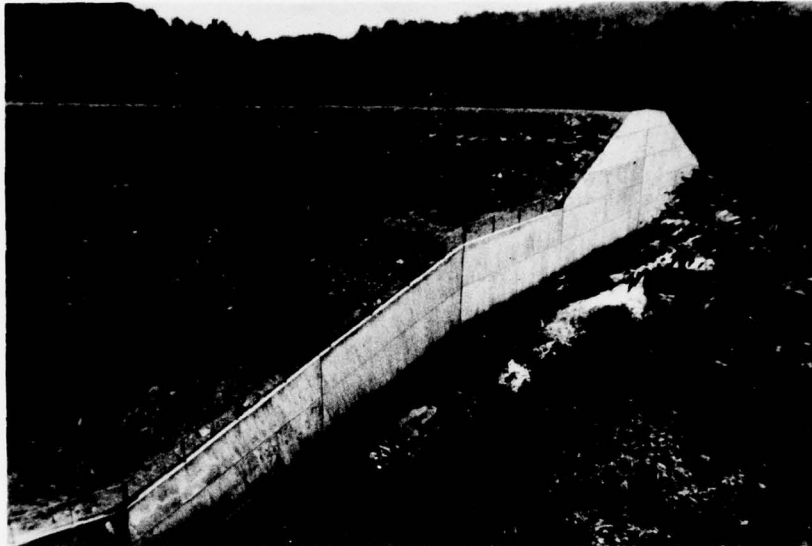
J. Embankment and Spillway Outlet Channel.  
View from Left Hillside.

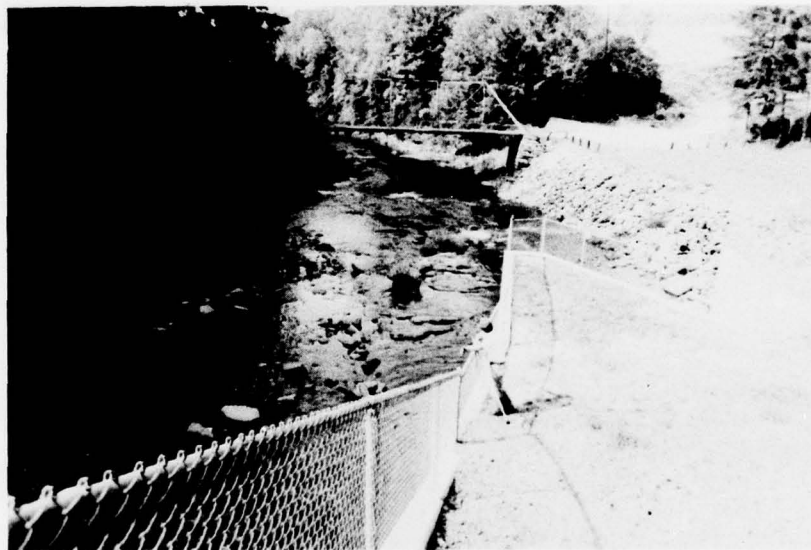
K. Downstream Channel.

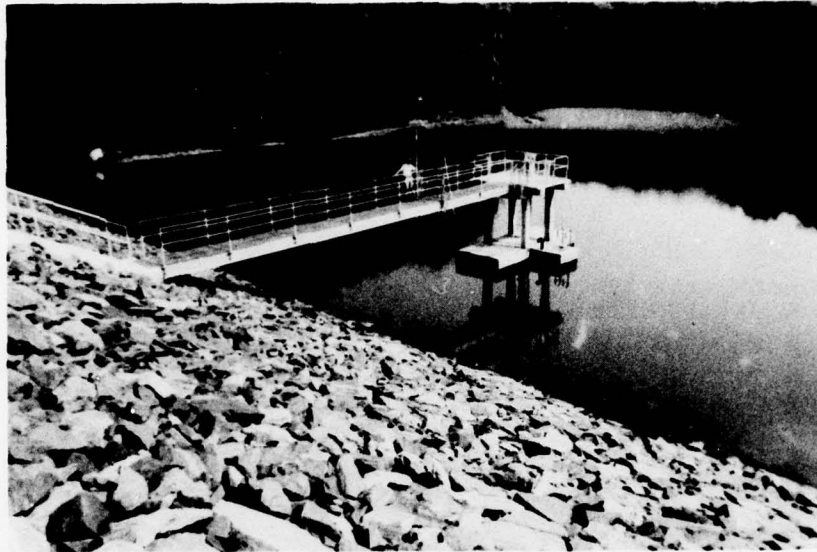
(2) Intake Structure. The drop inlet intake structure had no apparent deficiencies (Photograph L). Concrete was in good condition, all metalwork was painted, and the slide gate and gate valve stems were lubricated. The slide gate and gate valve opened easily during the inspection.

L. Intake Structure.

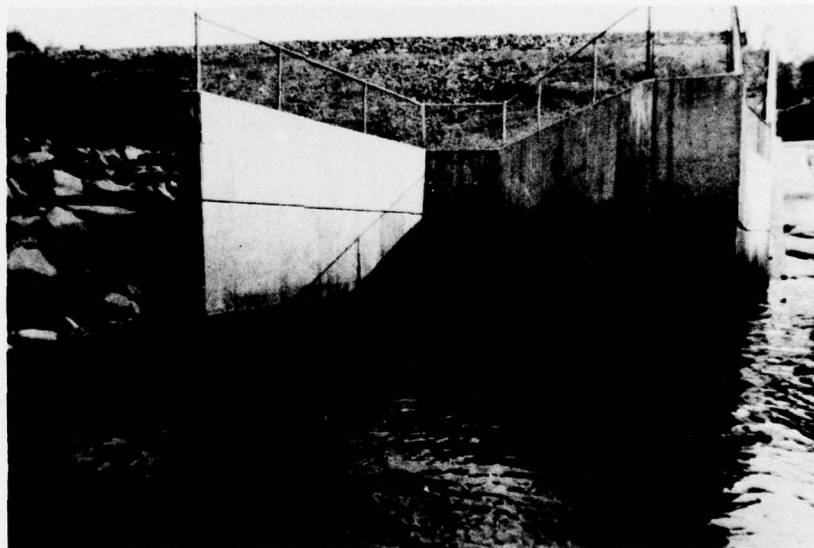
(4) Outlet Works Stilling Basin. The outlet works stilling basin had no apparent deficiencies (Photograph M).

M. Outlet Structure.
